Plasma Passivation of Selected MCT Samples

PRELIMINARY COMPARISON by EER Analysis

Quarterly Progress Report for the First Quarter, April - June, 1983

Report of N.V.L. Sample 1, 2, 3A, and 3B

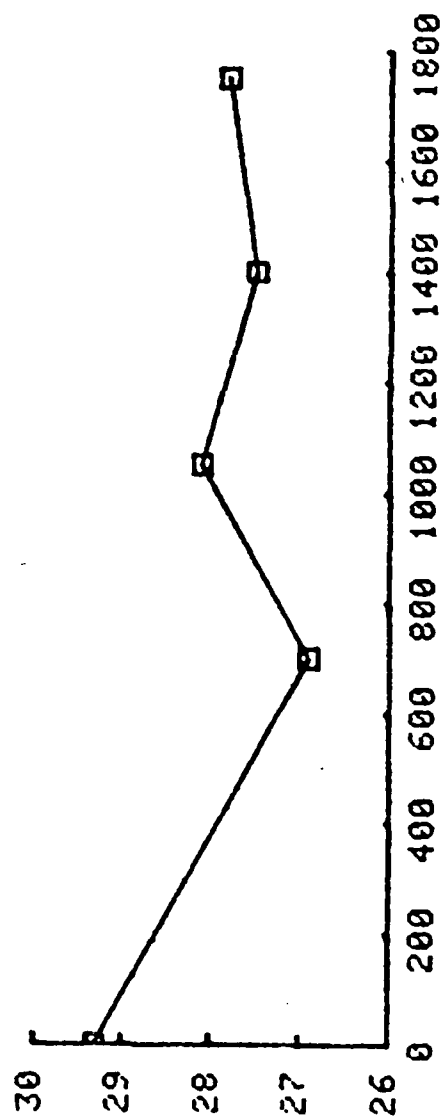
Figure 1

SAMPLE N.U.L. #1 DEPTH US. X AT TOP OF LAYER

Here again the high resolution composition profile shows that there has been a Hg depletion of the surface albeit not as extreme as in the case of sample 2. It could be that the usual Hg enrichment of the surface in L.P.E. materials has compensated for the loss imposed by the plasma deposition. Also, as can be seen in figure 2, here again, there does not seem to be anymore damage at the interface than anywhere else. Finally the average value of θ hovers around 2 as always for L.P.E. materials. Hence the minority carriers type is masked by the strong interaction of the thermalized electrons and holes.

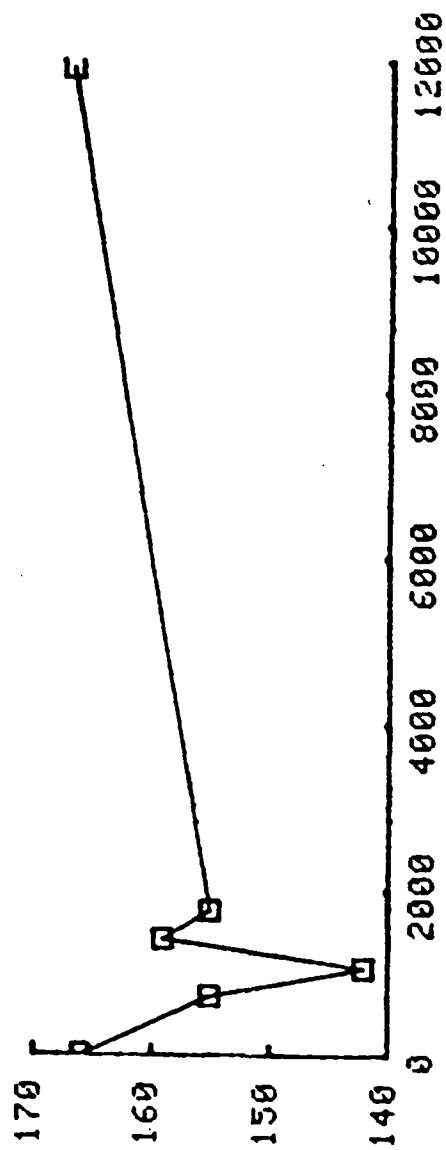
Figure 2

SAMPLE N.U.L. #1 DEPTH US. GAMMA AT TOP OF LAYER

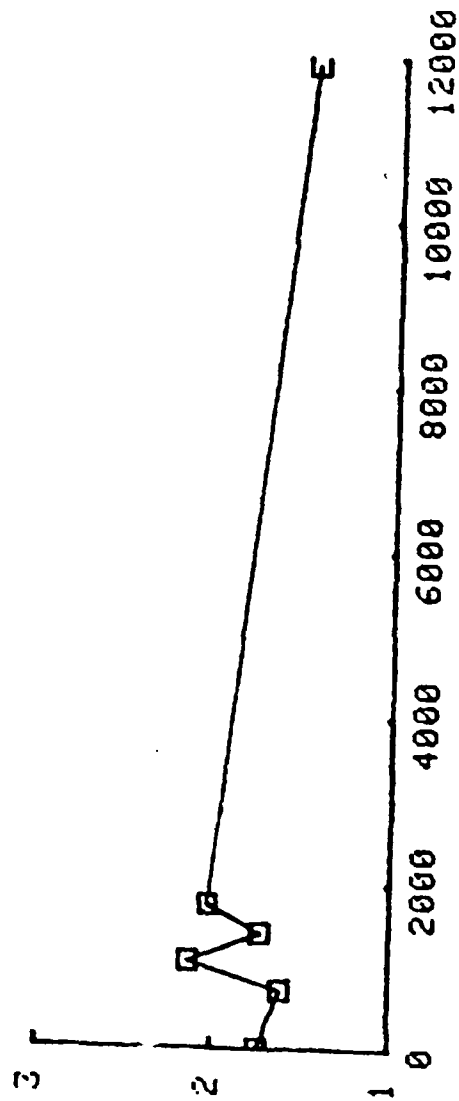
Figure 3

SAMPLE H.U.L. #1 DEPTH VS. THETA AT TOP OF LAYER

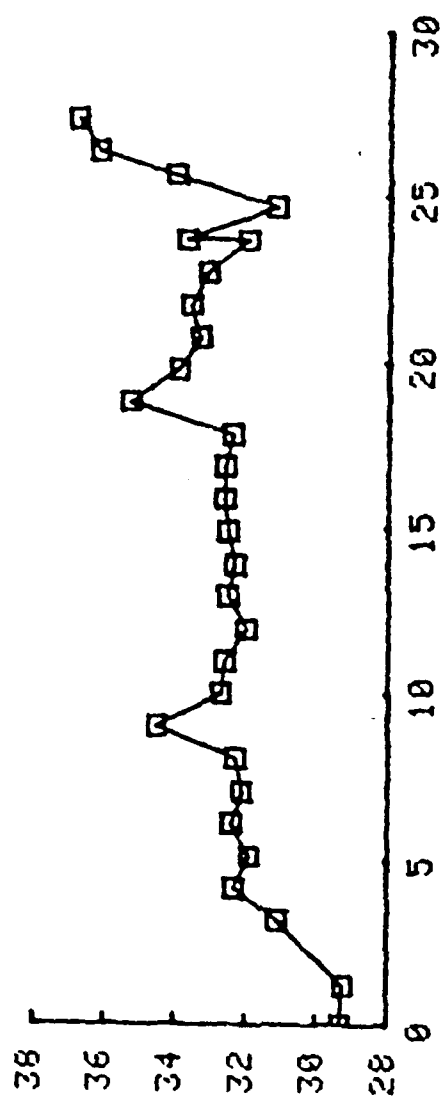
Figure 4

SAMPLE N.U.L. #1 DEPTH US. X / TOTAL PROFILE

The Hg enrichment in the first 5 μ in figure 4 is no surprise and is usually associated with growth termination in L.P.E. materials. In the bulk region the material is reasonably well behaved and could be considered state of the art with an average composition $X = 0.32 \pm 0.01$. The substrate/epilayer

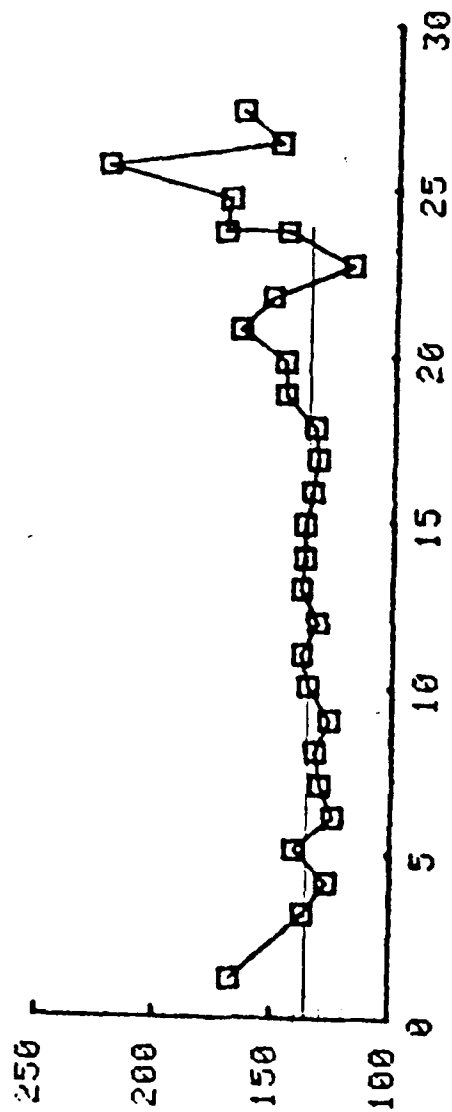
Figure 5

SAMPLE N.U.L. #1 DEPTH VS. GAMMA / TOTAL PROFILE

interface region is about 5μ and is larger than in materials where a non-contact polish method has been used. As shown in figure 5 the linewidth does not change much in the bulk of the material but is higher both near the surface and at the substrate interface. The latter is consistent with poor substrate surface preparation. Finally figure 6 shows that over most of the bulk region the value of θ is close to π and therefore the material would tend to be p-type. However charge interface defects generate a region around 26μ which is almost n-type.

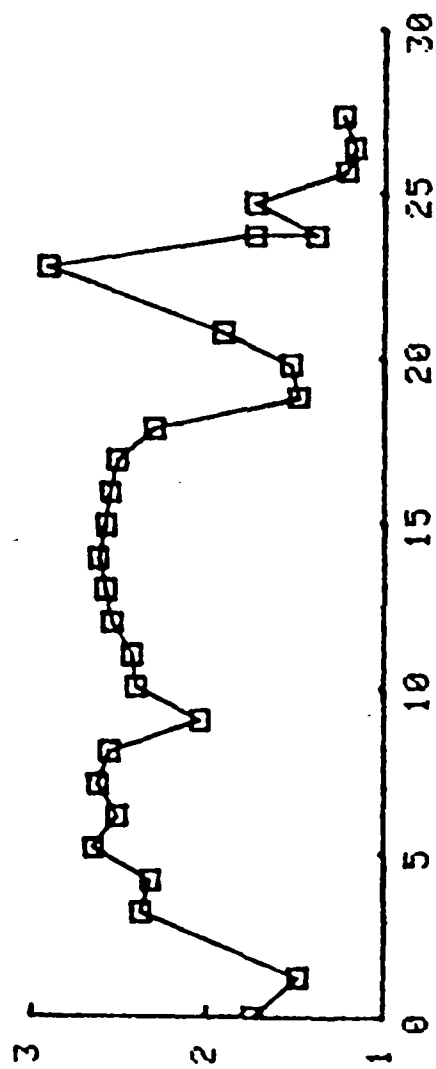
Figure 6

SAMPLE N.U.L. #1 DEPTH VS. THETA / TOTAL PROFILE

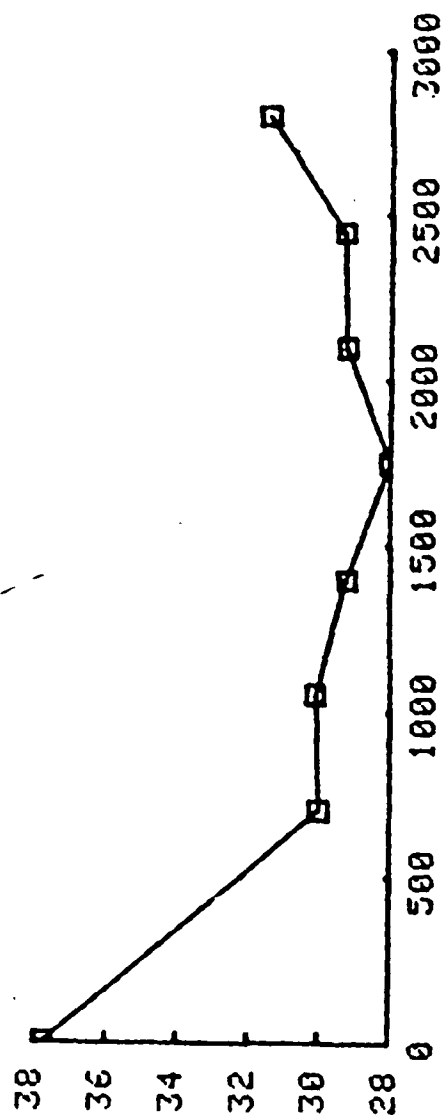
Figure 1

SAMPLE N.U.L. # 2 DEPTH IN ANGSTOMS VS. COMPOSITION X

The purpose of our measurements was to study the interface between the material and the plasma deposited oxide. The results shown in figure 1 indicate clearly that the interface has been impoverished in Hg since the value of X is 0.37 compared to an average value of 0.29 ± 0.01 in very good agreement with the reported composition. The depth of the impoverished region is less than 600 Angstroms.

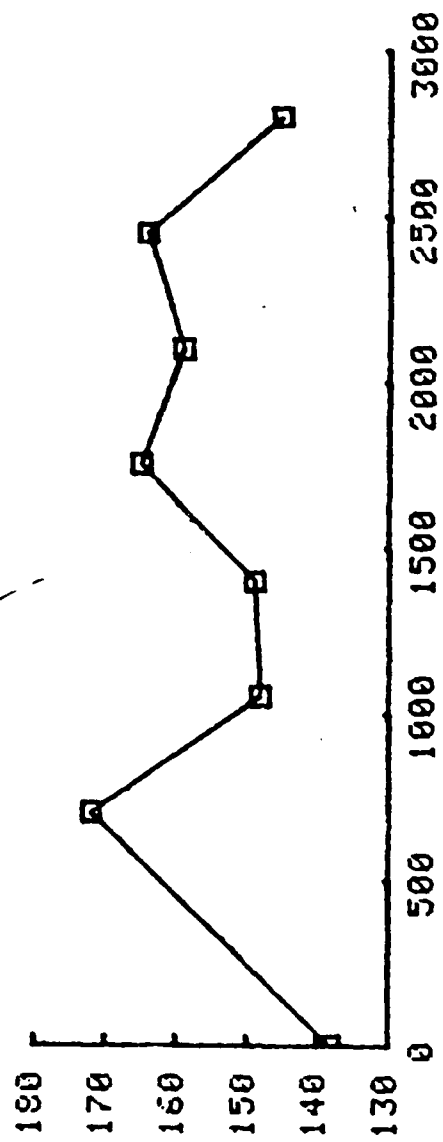
SAMPLE N.V.L. # 2 DEPTH IN ANGSTROMS VS. GAMMA IN MUS

The results shown in Figure 2 display Γ in function of the depth. It is clear that the value of Γ is not larger at the interface than it is at 3000 Angstroms and therefore that *there is no more damage at the interface than anywhere else*. On the other hand the average value of Γ is clearly excessive and the surface of this bulk material is not state of the art. It seems that it was not prepared with sufficient care to remove "as received" damages. Further evidence can be found in figure 3, where θ is displayed in function of depth. The average value is

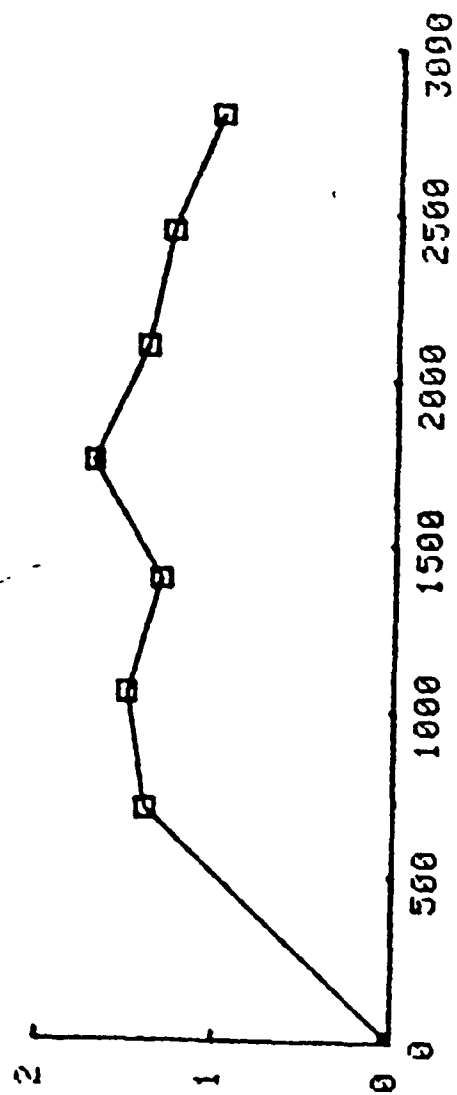
Figure 3

SAMPLE N.V.L. # 2 DEPTH IN ANGSTROMS VS. THETA

16 almost exactly $n/2$ except at the surface where it is zero, consistently with the reported type .

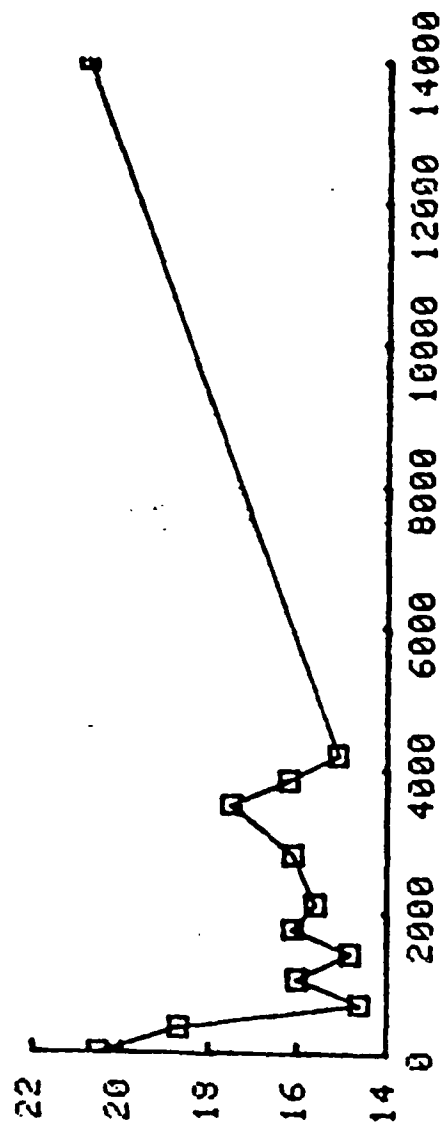
Figure 1

SAMPLE N.V.L. #3A DEPTH VS. X AT THE TOP OF THE LAYER

The first figure shows that while the first $\frac{1}{2} \mu$ of the layer is Hg enriched the immediate surface is clearly depleted, confirming that plasma deposition induces Hg depletion over a depth of about 500 Angstroms. A comparison of figure one with figure 4 shows that the low X values ($X \approx 0.16$) reached between 0.1 and 0.3 μ are significantly lower than the bulk average in this region. This result seems to indicate that the plasma deposition drives the Hg inward generating a Hg accumulated region adjacent to the Hg depleted region at oxide/epilayer interface.

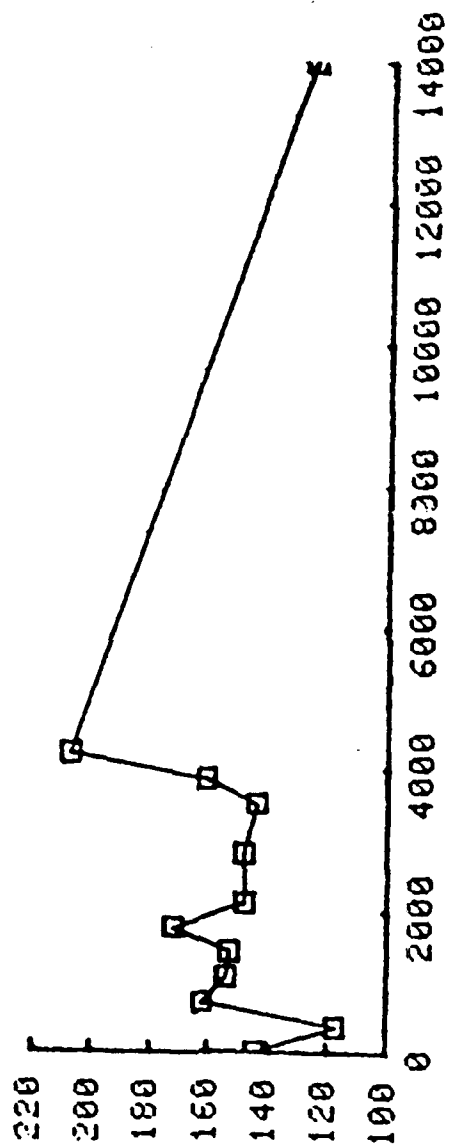
Figure 2

SAMPLE H.V.L. #3A DEPTH VS. GAMMA AT TOP OF LAYER

The second figure shows, one more time, that *the plasma deposition has not introduced new damage*. The third figure, on

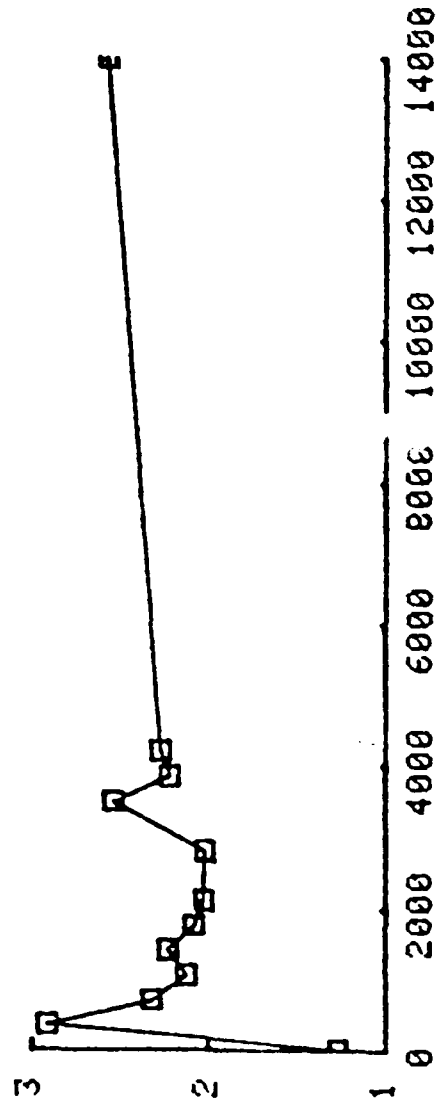
Figure 3

SAMPLE N.U.L. #3A DEPTH VS. THETA AT TOP OF LAYER

the other hand, clearly shows that the reported n-type of the material prevails only at the immediate oxide/epilayer interface while in the rest of the depth of the layer the material appears to be of mixed conduction type. It does show, however, that the type is unmasked, by the interface charges, at the interface oxide/epilayer.

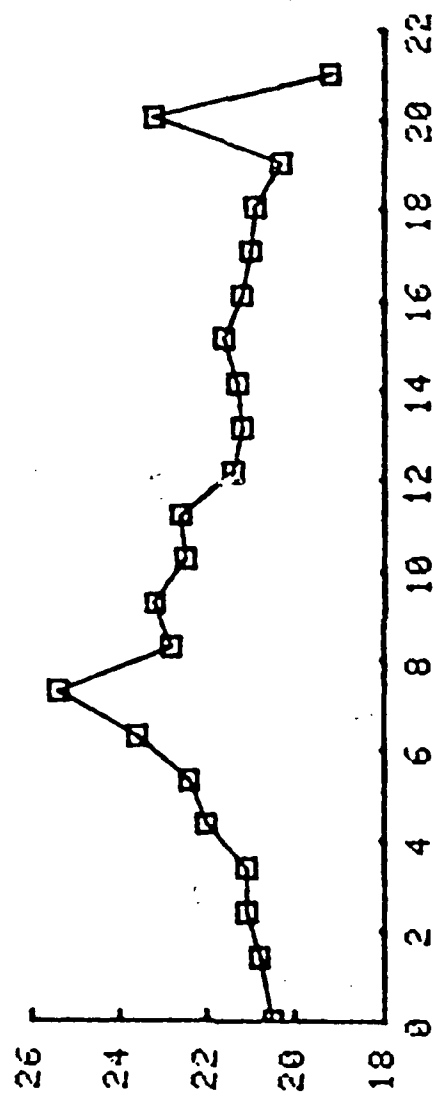
Figure 4

SAMPLE N.V.L. #3A DEPTH VS. %TOTAL PROFILE

Turning now to the results describing the properties of the entire layer we see in figure 4 that composition control is insufficient. The composition reaches a maximum of $X = 0.25$ around 6μ and decreases on each side to $X = 0.20$. This accident is not associated with a corresponding accident in the linewidth, indicating that it is due purely to poor control of the growth parameters and not to defects mediated diffusion. The fifth figure shows, here again, that the linewidth is fairly constant throughout most of the layer indicating that the defect density is essentially uniform and not too high (≈ 125 meV) for an L.P.E. material. The interface region is rather narrow ($\approx 2\mu$) and indicates that this epilayer was grown on a substrate which was probably prepared by a non contact method. Finally Figure 6 shows that θ has an average value hovering around 2.2 radians. This result is fairly typical of L.P.E. materials and the reported n-type is observable only at the oxide/epilayer interface when the field of the charged defects is neutralized by the interface charge.

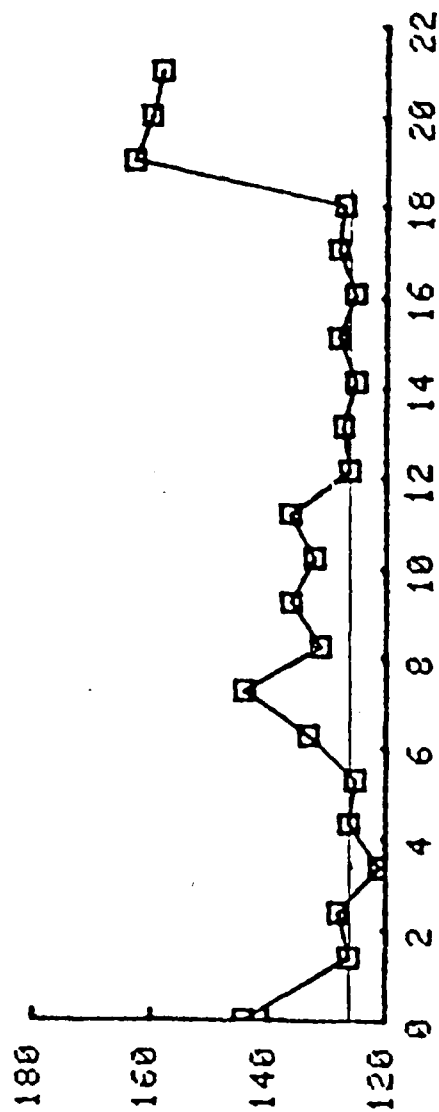
Figure 5

SAMPLE N.V.L. #3A DEPTH VS. GAMMA/TOTAL PROFILE

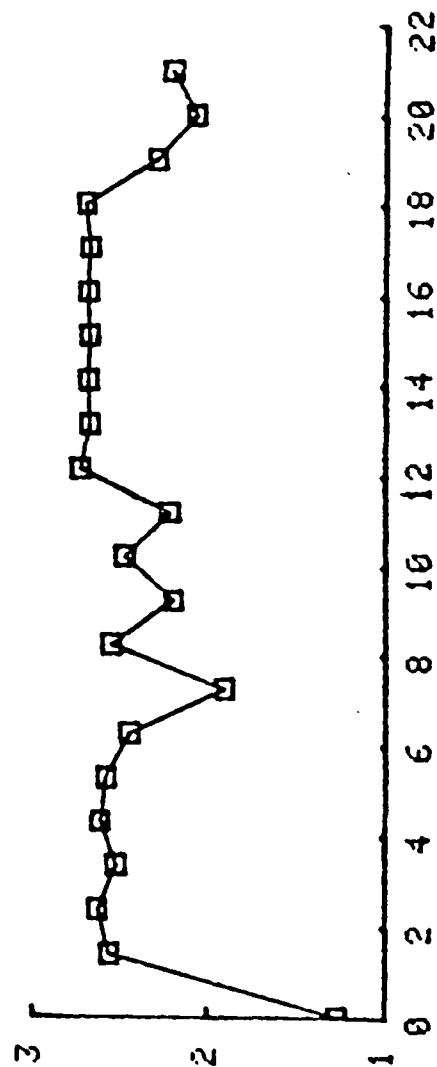
Figure 6

SAMPLE N.U.L. #3A DEPTH VS. THETA/TOTAL PROFILE

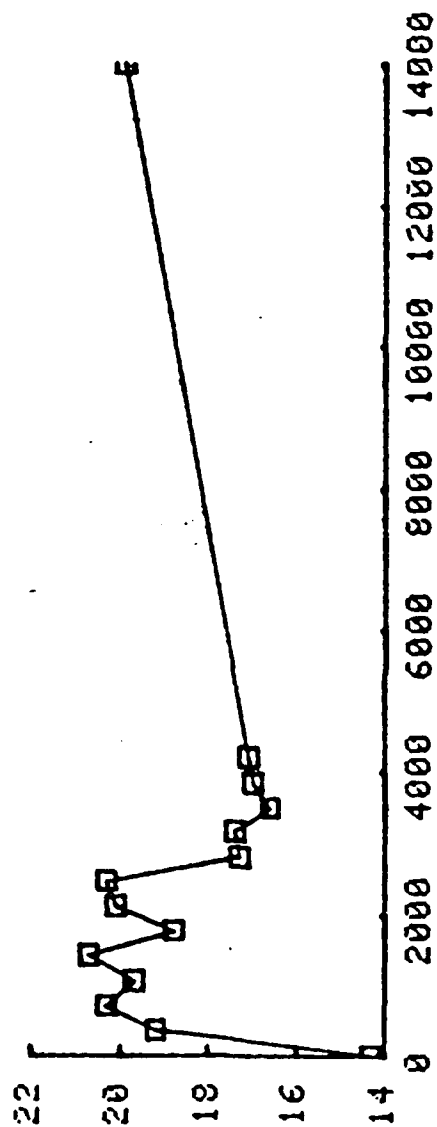
SAMPLE N.U.L. #38 DEPTH VS. X AT THE TOP OF THE LAYER

Figure 1 shows that the immediate oxide/epilayer interface is sharply lower in composition ($X \approx 0.14$) than the bulk which averages 0.21. The results in Figure 3 show mixed minority conduction type consistently with a high defects density.

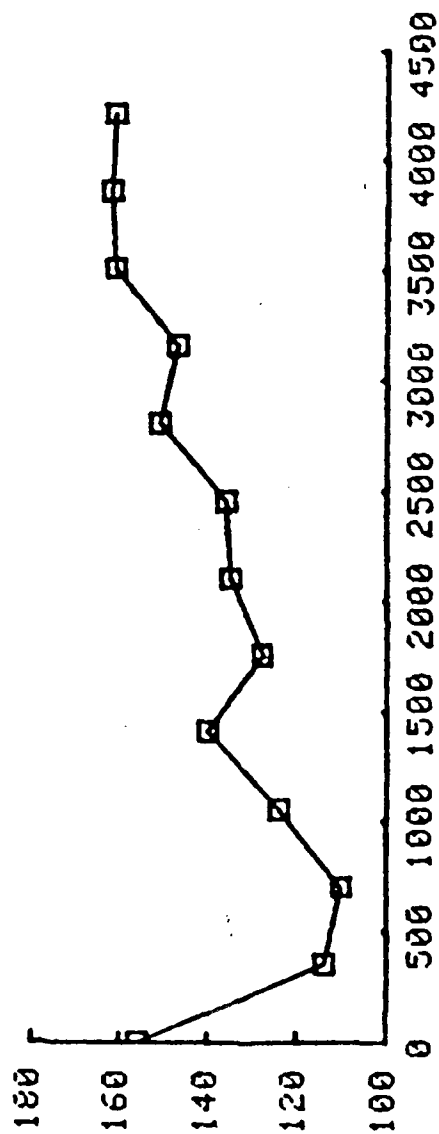
Figure 2

SAMPLE #38 N.V.L. DEPTH IN ANGSTROMS VS. GAMMA IN MUS AT THE TOP

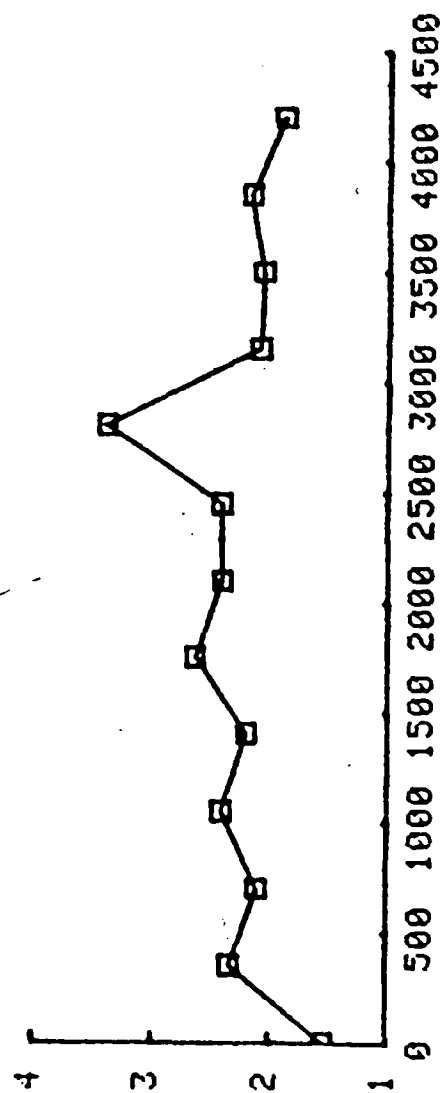
Figure 3

SAMPLE N.U.L. #38 DEPTH VS. THETA TOP OF THE LAYER

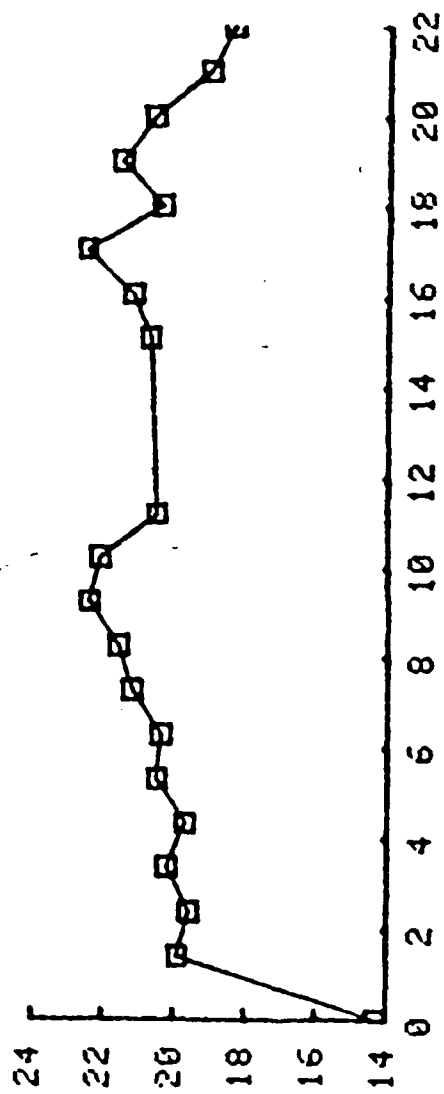
Figure 4

SAMPLE N.V.L. #38 DEPTH VS. % TOTAL PROFILE

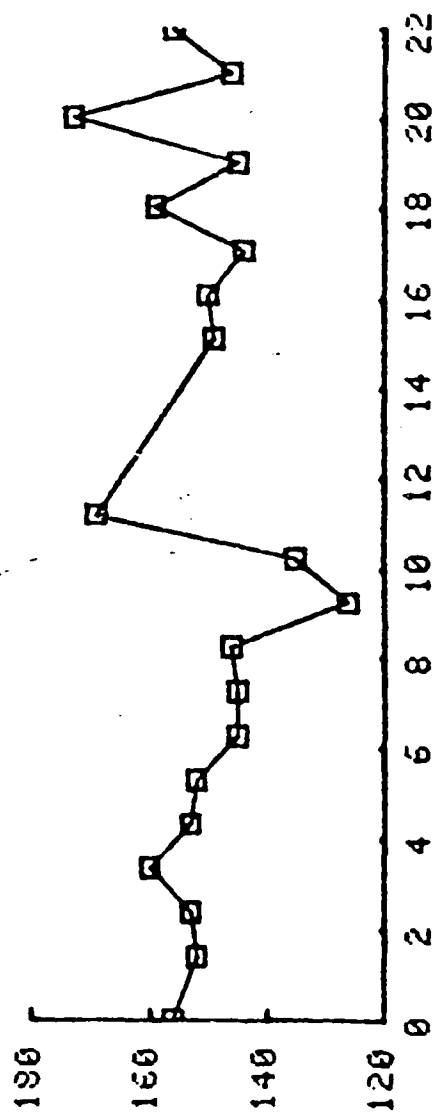
Figure 5

SAMPLE #3B H.V.L. DEPTH VS. GAMMA/TOTAL PROFILE

A rapid look at figure 5, which shows Γ vs. depth for the entire epilayer, is a good starting point to begin this discussion. Clearly this epilayer is more defectuous than Sample 3A. It could be that it has been treated differently or maybe it comes from a more imperfect area of the wafer.

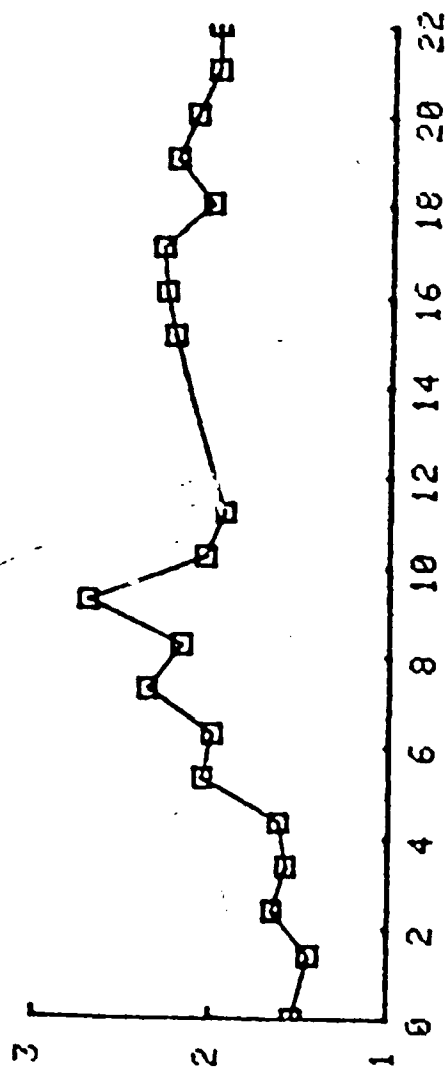
Figure 6

SAMPLE N.U.L. #38 DEPTH VS THETA TOTAL PROFILE
